1050799

**U.S. Environmental Protection Agency  
Vasquez Boulevard I/70 Superfund Site  
Replacement Certificate**

## LBP Assessment Results

Property ID # 3413 / 3846 Gilpin Street

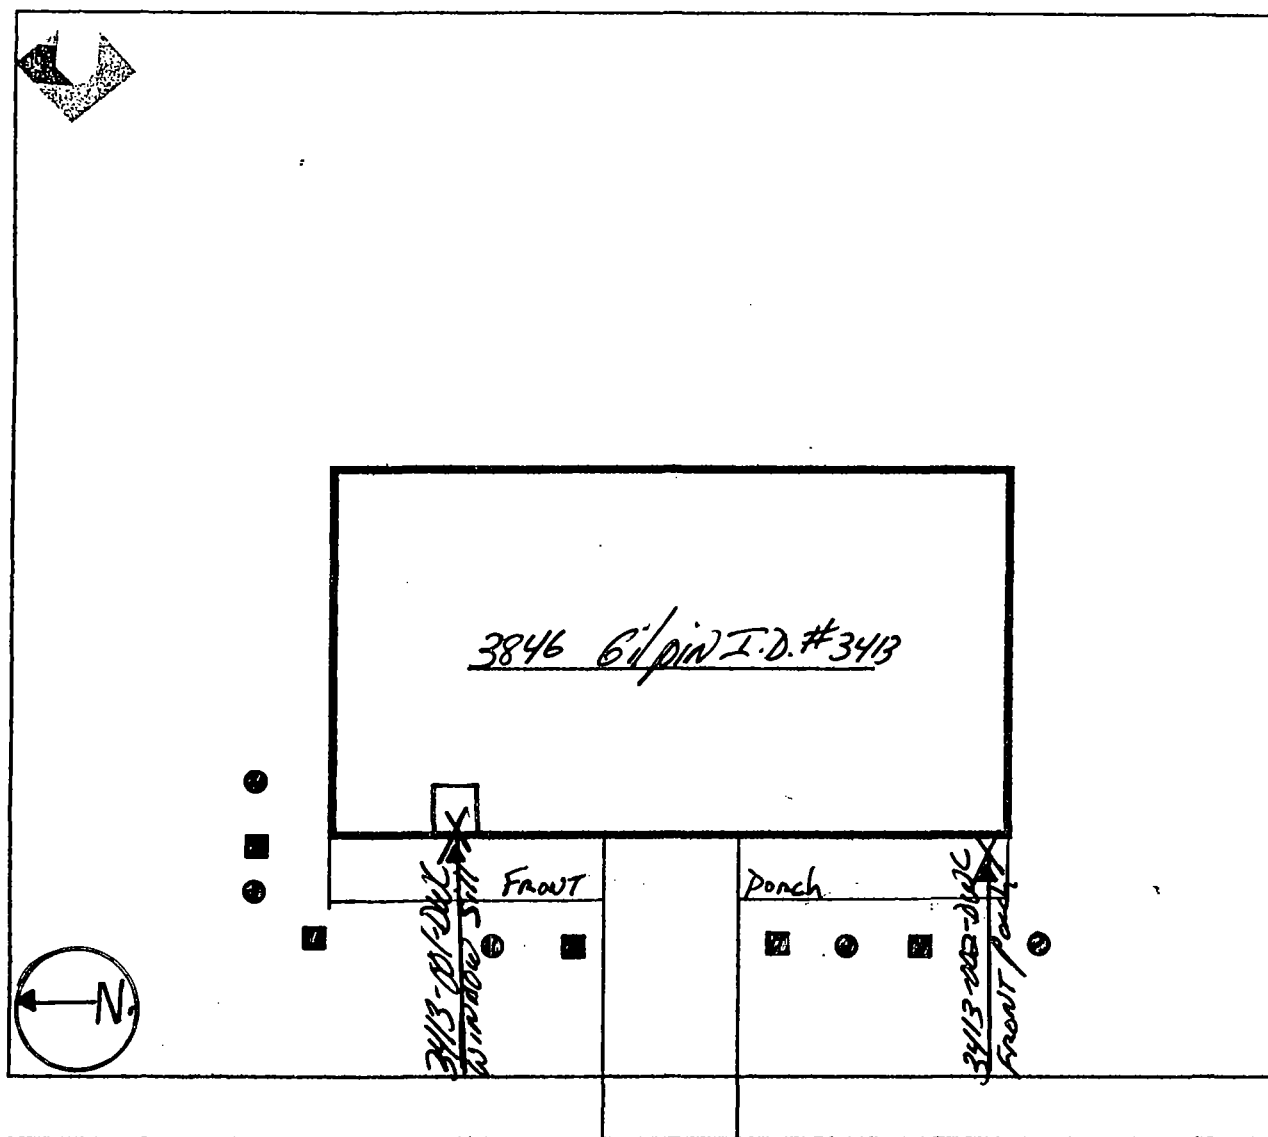
# 3846 Gilpin St.

- 1) 3413- 001- DWC 14:40 Hours 06-19-06
- 2) 3413- 002- DWC 14:50 Hours 06-19-06
- 3) 3413- 001- SCL 13:00 Hours • 06-19-06 1' offset
- 4) 3413- 002- SCL 13:10 Hours ■ 06-19-06 1' offset
- 5)
- 6)
